## Infrared Thermal Report

<b>Subject Scanned:</b>	Utility Chase and surrounding areas		
<b>Location:</b>	XXXXX NW Paisley Dr. Beaverton, OR 97006		
<b>Client:</b>	J.XXXXXX Roofing, Inc.		
<b>Image Time:</b>	11:50 am	<b>Image Date:</b>	01-13-2009

**Scope of Service:** Identify source of excessive moisture in attic space that has already been remediated by a professional mold company 12 months prior and now has extensive roof damage with visible mold growth once again.

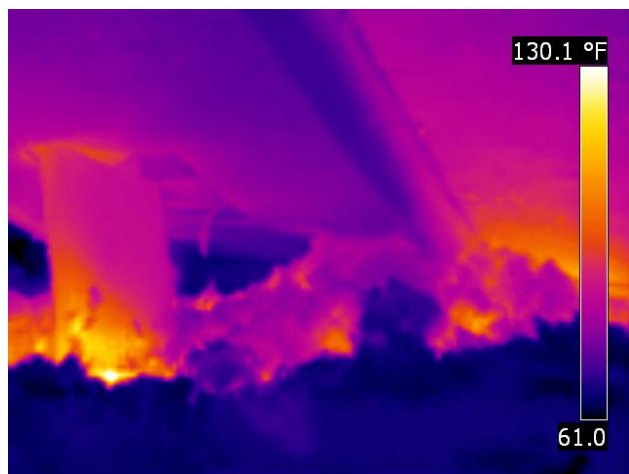
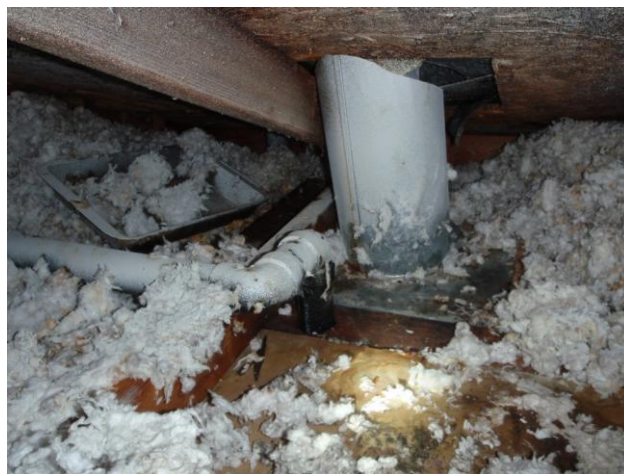
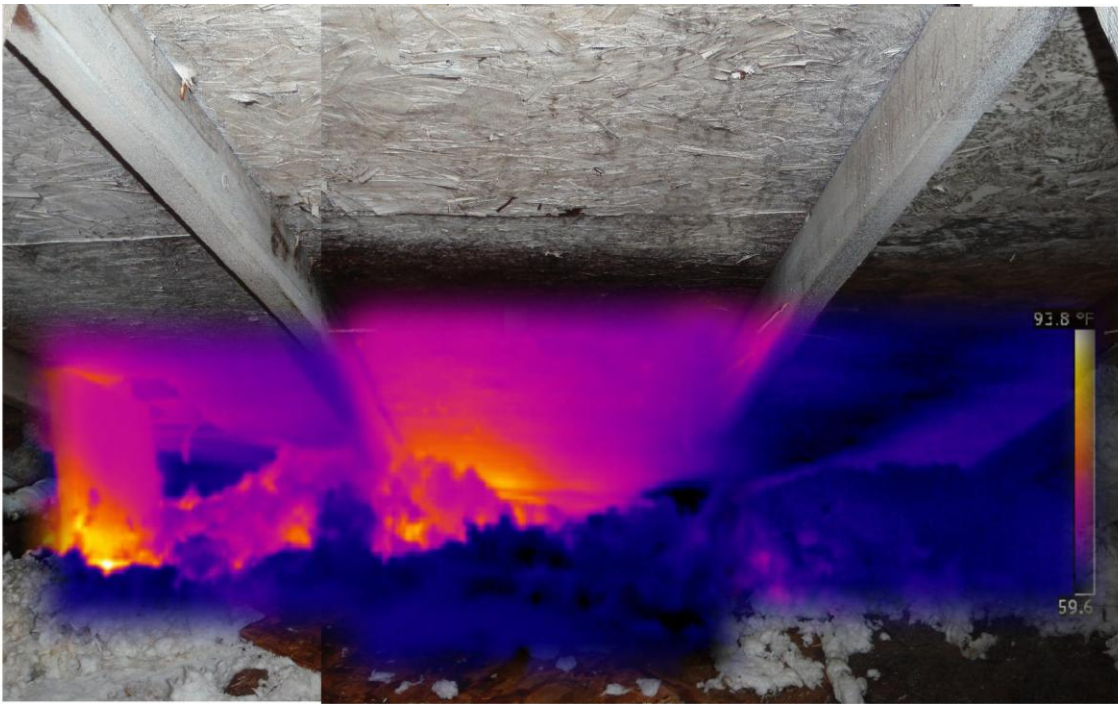
**Findings:** The source of excessive moisture in the attic space is the result of the combined furnace and water heater exhaust flue (B-Vent) disconnected within the confined utility chase. The exhaust flue is venting into the utility chase then migrating into the attic space. The by product of burning natural gas is moisture which is condensing on the roof sheathing that is saturated and in need of replacement. The B-Vent changes from rigid pipe to flex pipe inside the chase and back to rigid pipe prior to exiting the enclosure and into the attic then through the roof. This appears to have been disconnected for years and was likely the cause of the original mold issues. It is highly recommended a competent licensed HVAC tech immediately repair this for life safety reasons as high levels of carbon monoxide were also detected in the attic space.

**Description:** The infrared image shows the shielded exhaust vent with heated gasses exiting the hole where it passes through the ceiling and to the right at the end of the utility chase.

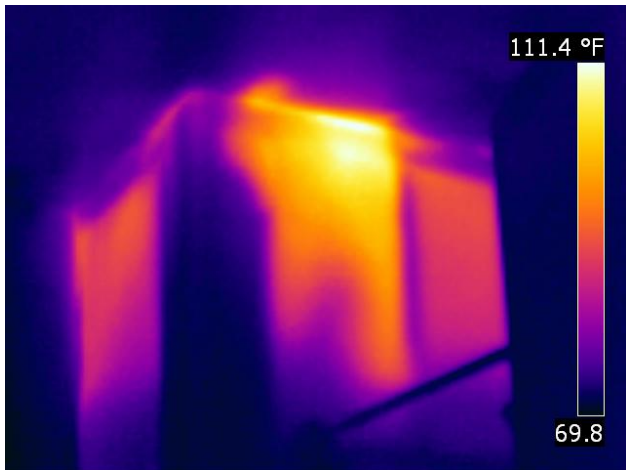
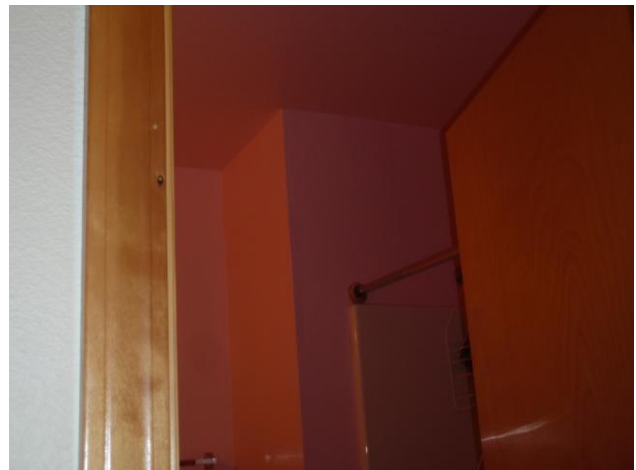
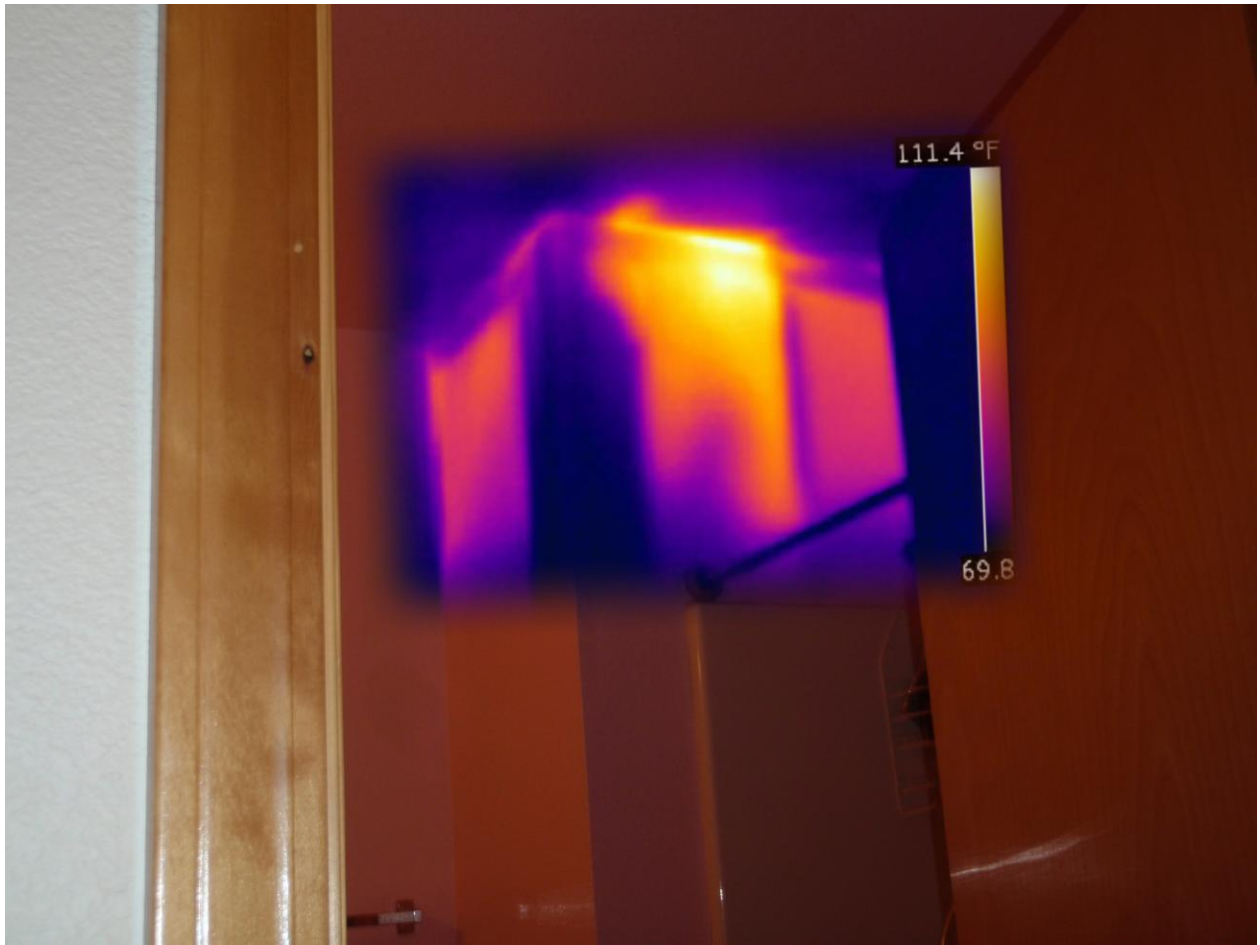
**Description:** The infrared image shows the interior wall in the shower stall backing the utility chase and below the attic space with a surface temperature of 111 degrees. This is the approximate location of the disconnected vent pipe.

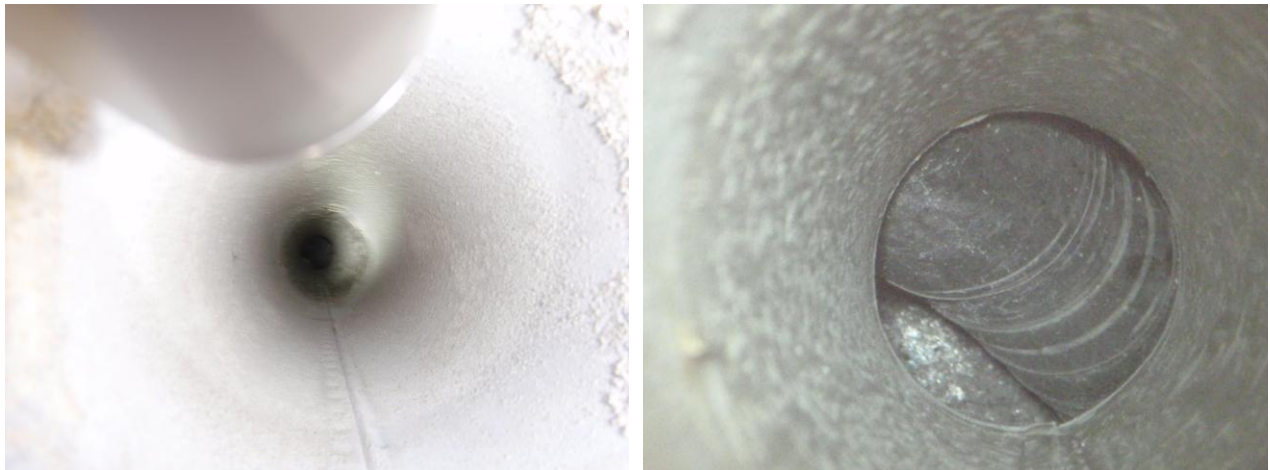
**Description:** The vent hood was removed at the roof top and the disconnected vent was confirmed.

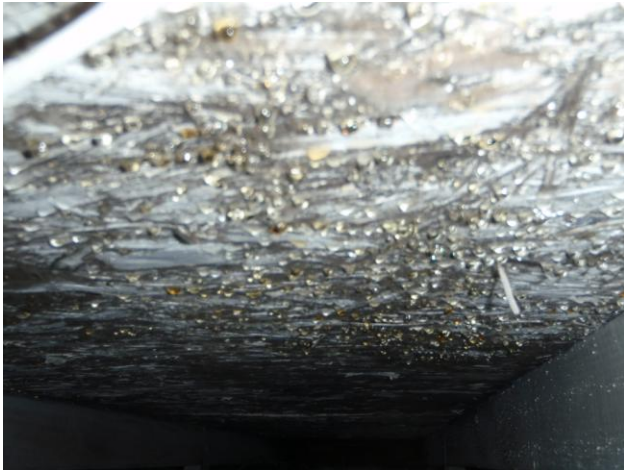
**Condensation on roof sheathing**

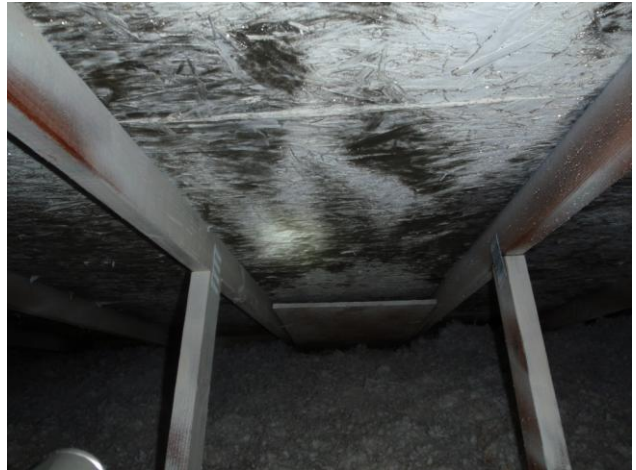
**Fungus/Wood decayed roof sheathing.**
