INSPECTION REPORT

11408 Pheasant Ridge Dr. - Happy Valley, OR 97086

Inspection Date: 11/25/2008 12:30 pm

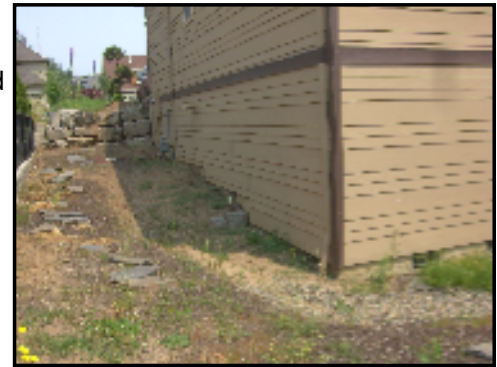
LOT DRAINAGE:

This lot drains surface water in a trough on the west side. There is evidence that water may pool in the back yard under and around the deck during the wet weather season.

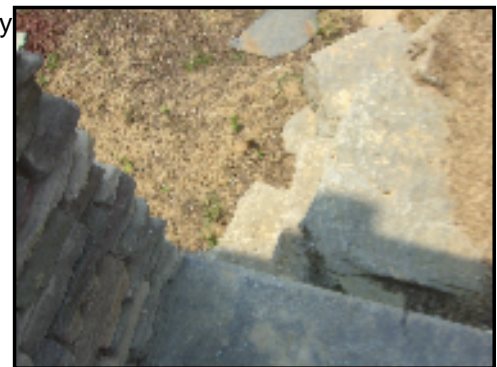
STAIRWAY RAILINGS:

1. **NONE** - The area to the right of the driveway has a drop off in excess of 30". Modern building standards require a guard rail be installed when the walking surface is 30" or more from the ground. Recommend installing a guard rail for safety.

NONE - The area to the right of the driveway has a drop off in excess of 30". Modern building standards require a guard rail be installed when the walking surface is 30" or more from the ground. Recommend installing a guard rail for safety.

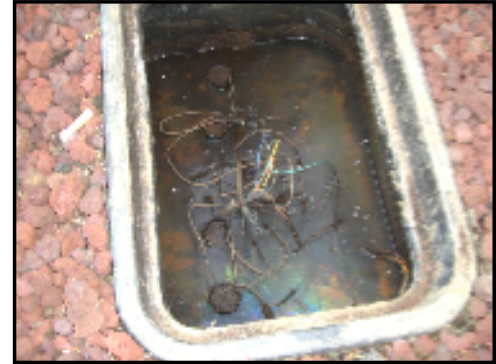
SPRINKLERS:

Yes - Automatic sprinklers were identified. Did Not Test. The evaluation of sprinkler systems is beyond the scope of this evaluation. It is recommended that information about the sprinkler system, stations, care and maintenance be obtained from the Seller. The sprinkler control was turned on but no water flowed. The control box is full of water, Recommend a landscape specialist evaluate and repair as needed.

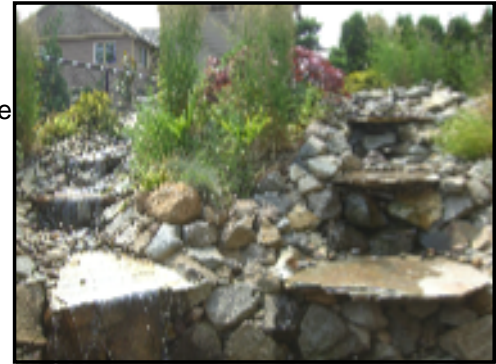
REMARKS:

The water feature at the rear is not flowing water from one side. Repairs may be needed consult a landscape specialist for instructions and operation. The water feature was not fully evaluated. Water features are beyond the scope of a general home inspection.

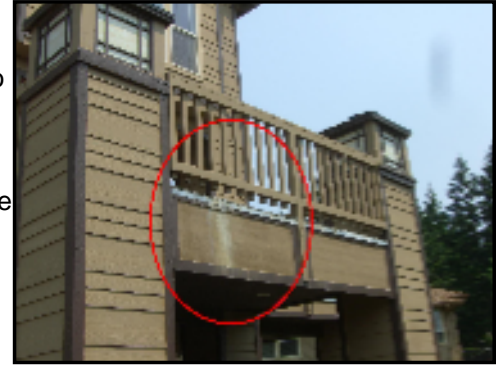
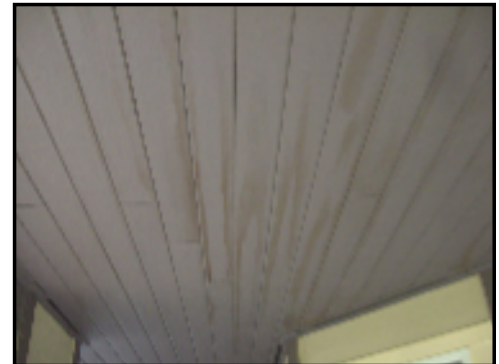
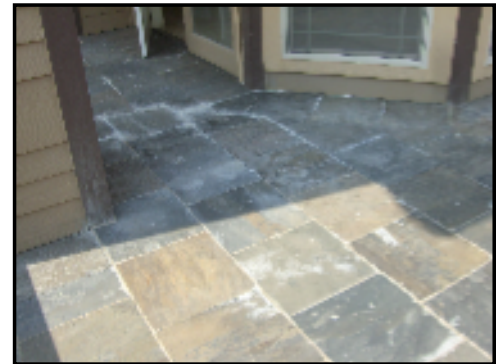
PATIO CONDITION:

2. **Attention Needed** - This patio that overhangs the deck is not water tight and leaks onto the deck below. The water is also draining into the light fixture below. The patio appears to pond water in areas. Past attempts to repair the leaking patio were observed. The flashings at the patio to home connection can not be seen due to the fiber cement siding being in direct contact with the surface. Fiber cement siding is recommended to have a 2" gap between all walking surfaces. The patio drains over the edge and onto the deck and stairway below. This entire deck surface and water proofing membrane below will likely need replaced to make it water tight as designed. Recommend a licensed contractor specializing in patio coverings and water tight membranes further evaluate and repair as needed.

Attention Needed - This patio that overhangs the deck is not water tight and leaks onto the deck below. The water is also draining into the light fixture below. The patio appears to pond water in areas. Past attempts to repair the leaking patio were observed. The flashings at the patio to home connection can not be seen due to the fiber cement siding being in direct contact with the surface. Fiber cement siding is recommended to have a 2" gap between all walking surfaces. The patio drains over the edge and onto the deck and stairway below. This entire deck surface and water proofing membrane below will likely need replaced to make it water tight as designed. Recommend a licensed contractor specializing in patio coverings and water tight membranes further evaluate and repair as needed.

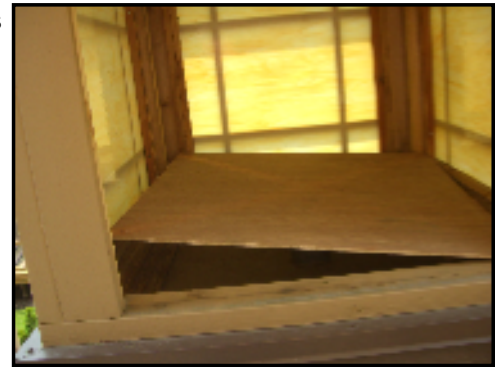
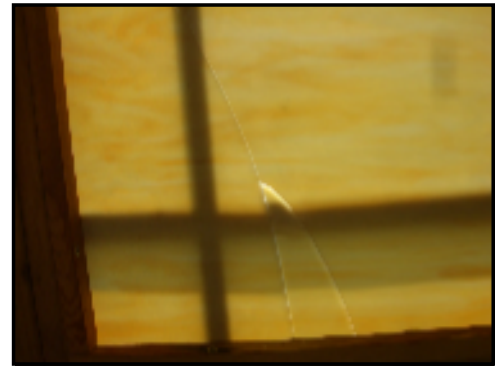
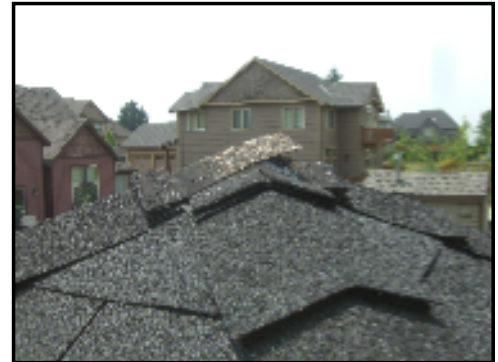
LIGHTING:

Attention Needed - The three light fixtures are in need of repair. All three are missing the top ridge cap, one has a cracked lens, and one has a interior wood ceiling that has fallen. Recommend a licensed contractor repair as needed.

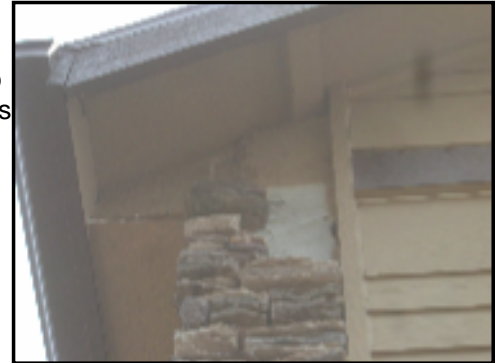
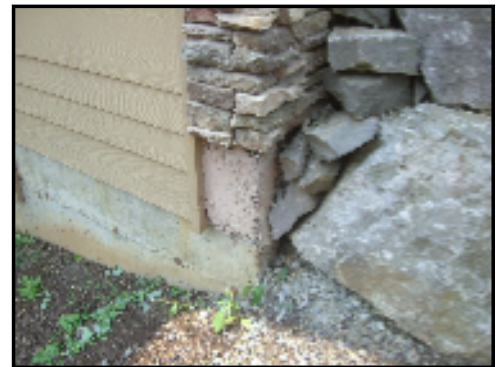
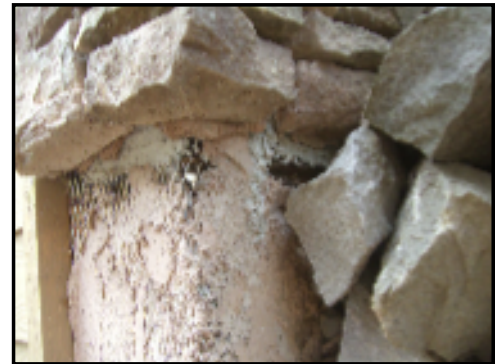
STONE CONDITION:

3. **Attention Needed** - The synthetic stone is incomplete in areas. The incomplete stone allowed the underlying lath and skim coat to be observed. The manufacturer/brand of this stone is unknown. Most of the stone manufacturers require a minimum 1/2" scratch coat of mortar be installed prior to the stones. The areas that could be observed are less than 1/2". Recommend a licensed mason specializing in synthetic stone applications evaluate and repair as needed.

Attention Needed - The synthetic stone is incomplete in areas. The incomplete stone allowed the underlying lath and skim coat to be observed. The manufacturer/brand of this stone is unknown. Most of the stone manufacturers require a minimum 1/2" scratch coat of mortar be installed prior to the stones. The areas that could be observed are less than 1/2". Recommend a licensed mason specializing in synthetic stone applications evaluate and repair as needed.

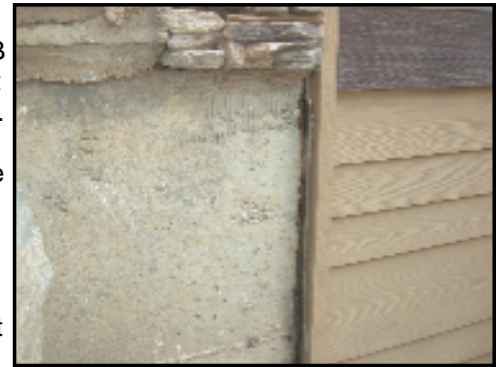
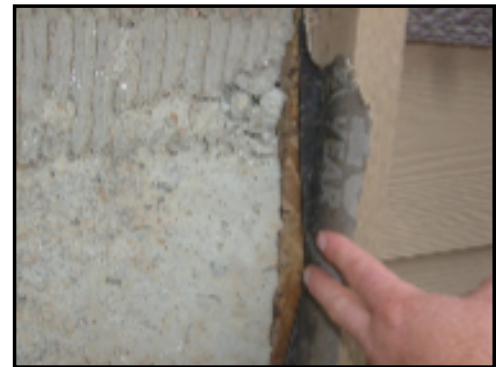
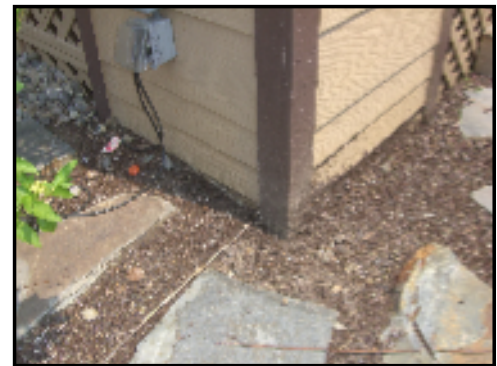
OTHER CONDITIONS:

4. **Attention Needed** - The area to the north west corner has the building paper and OSB sheathing exposed. These materials are not designed to be exposed and will deteriorate. Recommend a licensed contractor evaluate this connection and repair as needed. There are areas where the siding and trims are in direct contact with the ground, these areas will prematurely deteriorate. Ideally, there should be 6 inches clearance between the exterior cladding and the ground. This is not always possible and sometimes you can't attain the recommended 6". It is important to maintain some clearance so that you can keep an eye out for signs of wood destroying insects.

Attention Needed - The area to the north west corner has the building paper and OSB sheathing exposed. These materials are not designed to be exposed and will deteriorate. Recommend a licensed contractor evaluate this connection and repair as needed. There are areas where the siding and trims are in direct contact with the ground, these areas will prematurely deteriorate. Ideally, there should be 6 inches clearance between the exterior cladding and the ground. This is not always possible and sometimes you can't attain the recommended 6". It is important to maintain some clearance so that you can keep an eye out for signs of wood destroying insects.

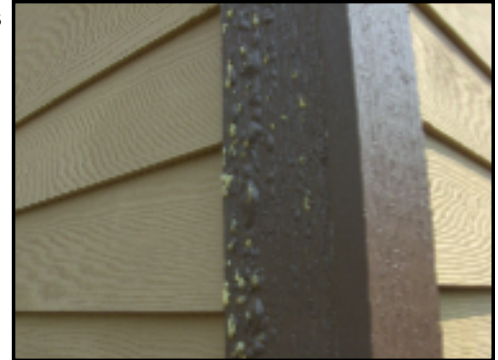
**PAINT STAIN
CONDITION:**

There are areas of the trims that the paint is bubbling from the sap in the wood.

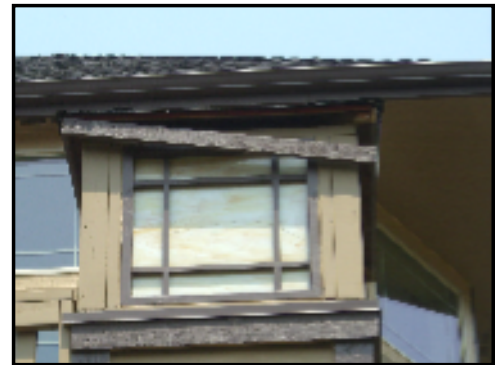
**MOLDINGS & TRIM
CONDITION:**

Attention Needed - The trim board at the rear is loose and needs reattached.

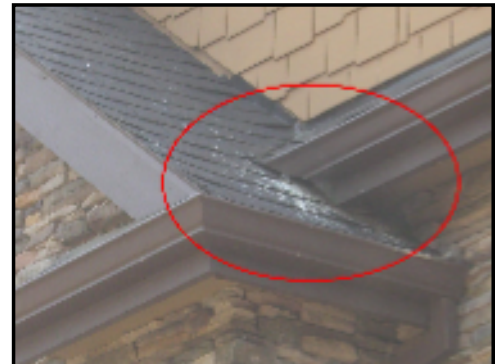
**EAVES/OVERHANGS
CONDITION:**

Attention Needed - There is a large gap at the front patio eave. Birds are currently nesting in the eaves. Recommend repair.

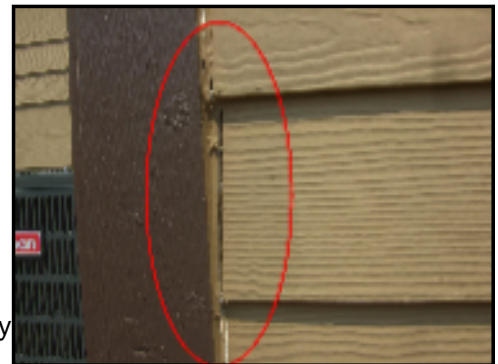
CAULKING CONDITION:

Recommend the addition of caulking to the vertical siding corner and window joints. This will help to prevent moisture entry by wind driven rain. Recommend adding sealant to the brick/trim joints. All wood, siding and trim, joints should be well sealed to prevent moisture intrusion and damage. Wood-to-wood joints at the windows and trim areas should also be monitored and sealed as necessary. Monitor and maintain areas for proper caulk coverage. Periodically re-caulk as necessary.

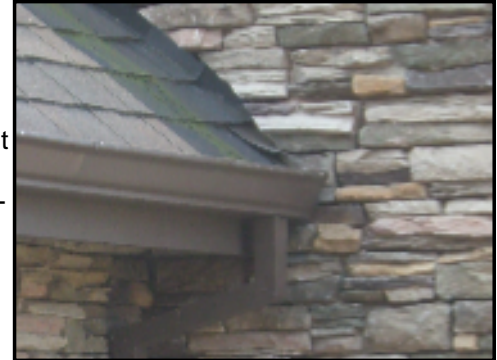
**DIVERTER KICK-OUT
FLASHINGS:**

5. **Attention Needed** - The diverter kick-out flashings are inadequate. These flashings are used above the termination of a lower roof and a vertical wall. The flashing helps to divert water away from the wall to prevent moisture damage within the wall, Recommend the installation of diverter kick-out flashings by a licensed Roofer.

Attention Needed - The diverter kick-out flashings are inadequate. These flashings are used above the termination of a lower roof and a vertical wall. The flashing helps to divert water away from the wall to prevent moisture damage within the wall, Recommend the installation of diverter kick-out flashings by a licensed Roofer.

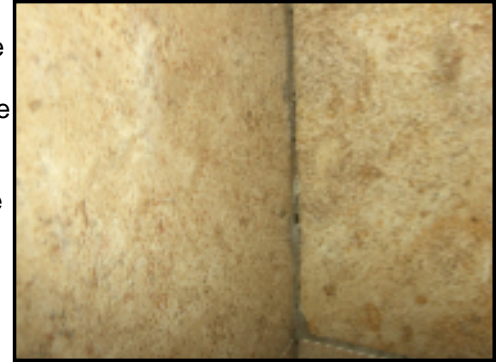
**TUB/SHOWER
SURROUND:**

The water proofing of tile surrounds are beyond the scope of this evaluation only the installer knows how the underlayment was installed. Resealing of the tiles and grout are routine maintenance. Chipped grout was observed, recommend re grouting and sealing to maintain the water proofing of the surround. Tiles need re grouted and or sealed on occasion.

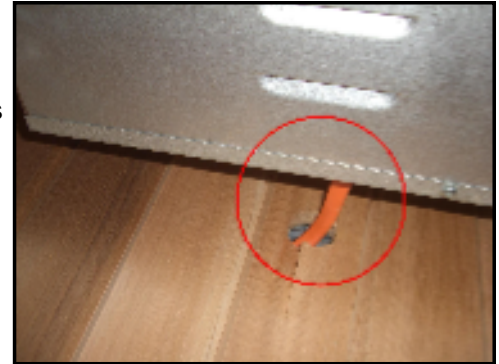
ADDITIONAL ITEMS

SMOKE ALARMS: Installed.
CARBON MONOXIDE DETECTOR: No unit was found, but they are recommended on each living floor in homes with gas appliances and/or attached garages.
CENTRAL VACUUM: The home appears to be rough plumbed for the addition of a central vacuuming system.
FIRE EXTINGUISHERS: Consideration should be given to purchasing fire extinguishers for each floor of the home.
REMARKS: **Attention Needed** - The electrical for the sauna is not enclosed in flex conduit as recommended by the manufacturer. Recommend a licensed electrician repair as needed.

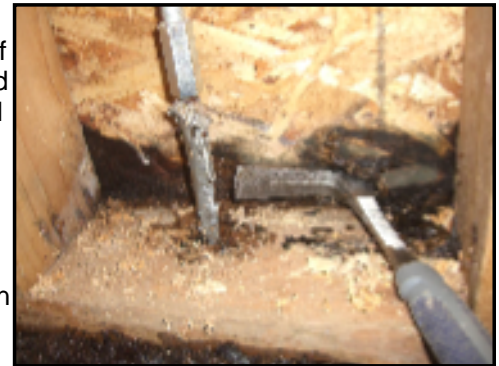
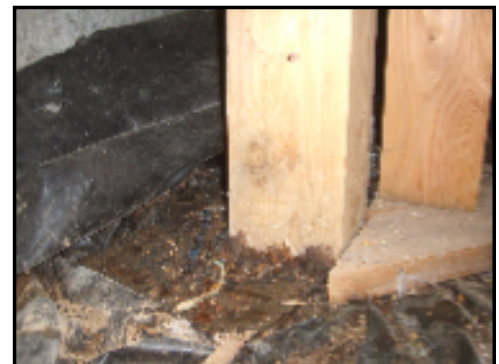
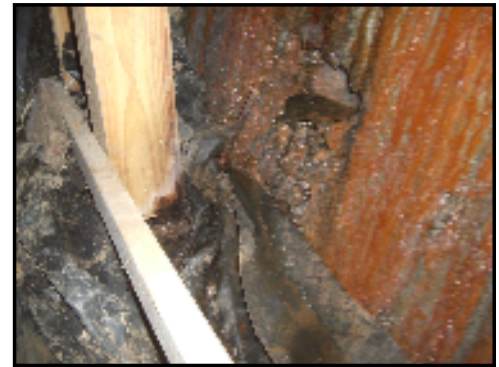
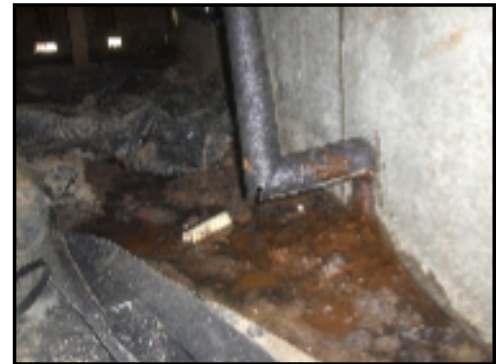
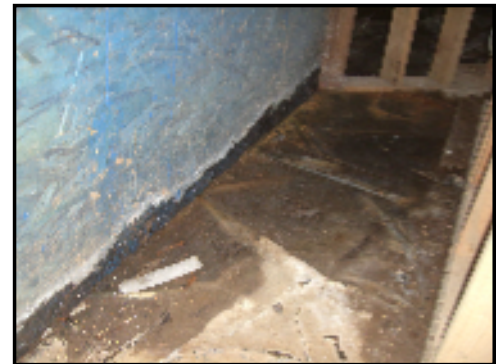
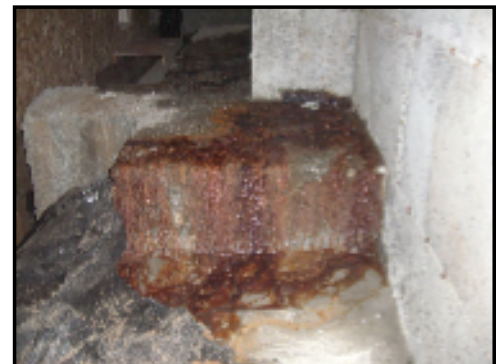
**MATERIAL
DETERIORATION:**

7. **Attention Needed** - Water is currently seeping in at the concrete wall in the front of the home and cascading over onto the wood framing. The OSB sheer wall is deteriorated with mushrooms and fungus beginning to grow. The support posts at this location are wet and beginning to deteriorate. Water is currently pouring in where the water main enters the foundation. It was previously mentioned that the surface water flows down around the right side of the structure during the wet season. It is recommended a licensed drainage contractor further evaluate and repair the water penetration issues and a licensed contractor replace the damaged materials.

Attention Needed - Water is currently seeping in at the concrete wall in the front of the home and cascading over onto the wood framing. The OSB sheer wall is deteriorated with mushrooms and fungus beginning to grow. The support posts at this location are wet and beginning to deteriorate. Water is currently pouring in where the water main enters the foundation. It was previously mentioned that the surface water flows down around the right side of the structure during the wet season. It is recommended a licensed drainage contractor further evaluate and repair the water penetration issues and a licensed contractor replace the damaged materials.

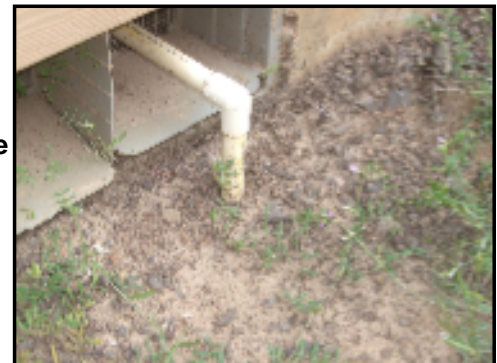
TPR DRAIN PIPE:

Yes - The TPR drain pipe is installed to drain to the exterior. If moisture is ever noticed dripping from this pipe stay away and contact a licensed plumber for repair ASAP. **Recommend raising the drain pipe termination out of the ground.**

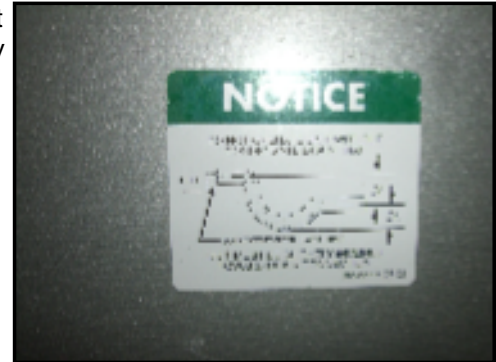
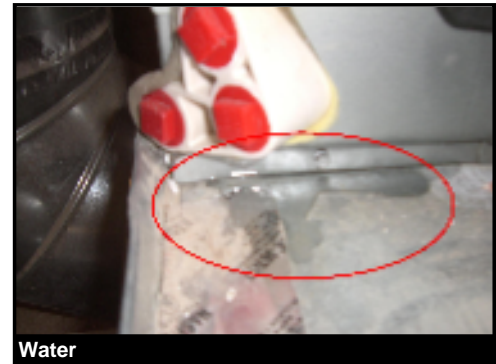
8. **Attention Needed** - Both of the units do not have a condensate drain trap as required by the manufacturer. The lower level unit is currently leaking. Recommend a licensed HVAC tech further evaluate and repair as needed.

Attention Needed - Both of the units do not have a condensate drain trap as required by the manufacturer. The lower level unit is currently leaking. Recommend a licensed HVAC tech further evaluate and repair as needed.
